Service Advisory SA011

PowIVac 3000 Amp Heat Sink Upgrade

May 15, 2010

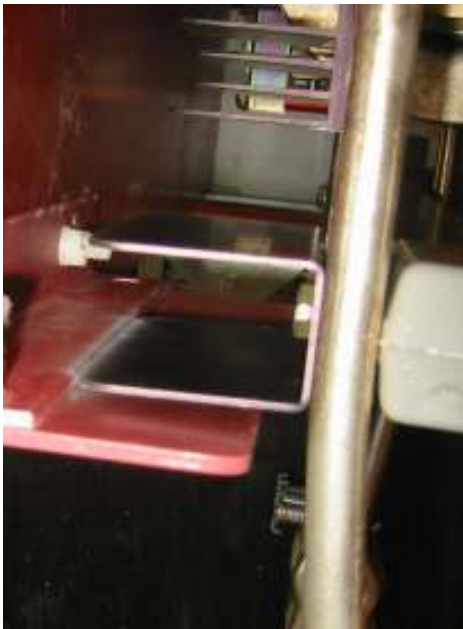
Partial discharge is indicated by the presence of white shadowing on the insulating barrier in close proximity to the upper stab heat sink assembly. This shadowing may progress to darker and black tracks after extended periods.

Photo of original U shaped heat sink with minimal, non critical signs of partial discharge.

CORRECTIVE ACTION: Powell has designed a replacement heat sink assembly with improved dielectric properties which can be easily installed. After the breaker is safely removed from service and placed in a clear work area, this part can be changed out in less than five minutes. Insulating barriers should be checked for partial discharge damage. In most cases, a routine maintenance cleaning with

denatured alcohol will be the only action required. If the barriers are questionable, they should be replaced. Upon request, Powell will supply the replacement heat sink assembly at no cost for customer installation. All other components are considered maintenance items.

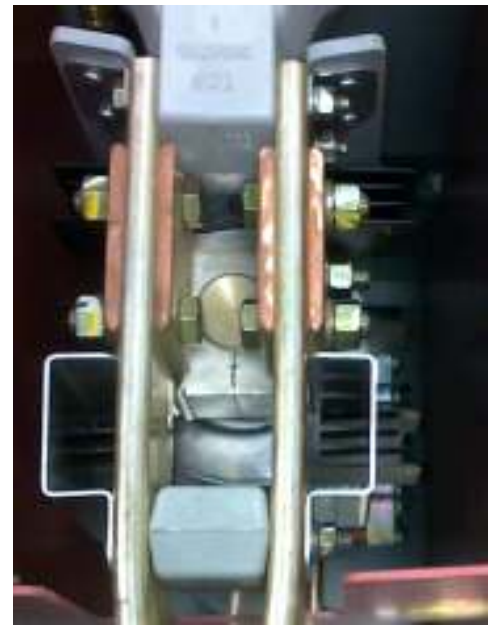
Photo with replacement heat sink assembly
